## Case Report

# Intermittent Right Ventricular Outflow Tract Capture due to Chronic Right Atrial Lead Dislodgement

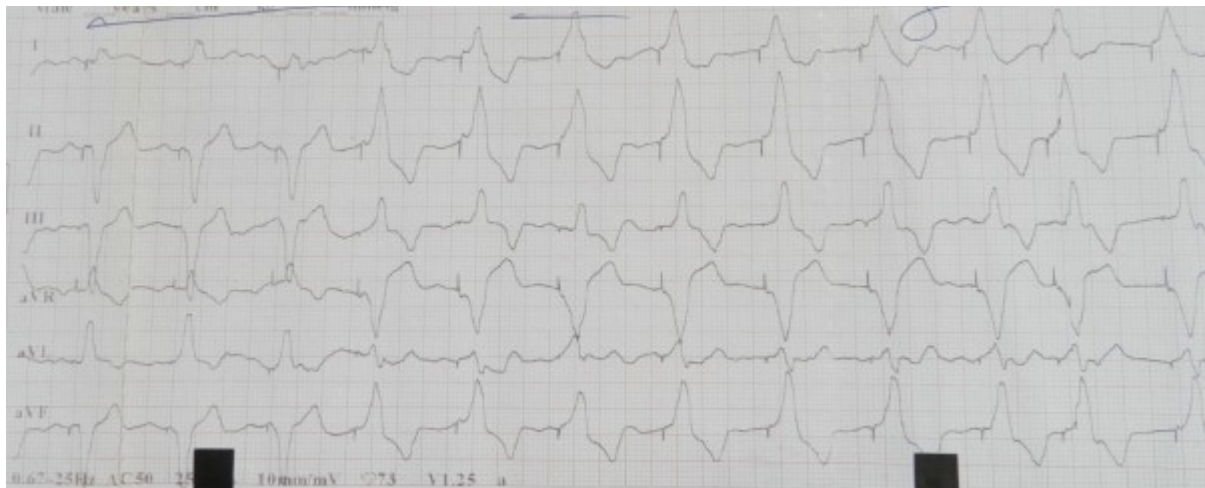
**Figure 1:** Baseline ECG showing spontaneous paced QRS complexes. The ECG shows paced QRS complexes at an approximate rate of 75 bpm. The first three complexes show p waves followed by paced QRS complex with left superior axis consistent with atrial sensed right ventricular apical pacing. The subsequent complexes do not show any p waves and have paced complexes with an inferior axis; within these complexes itself the sixth, seventh, tenth and eleventh complex show subtle widening of QRS and leftward shift in axis (aVL positive) as compared to fourth, fifth, eighth, and ninth complexes (aVL equiphase). Only one pacemaker spike is seen and no clear p wave is made out.

Thus in the initial complexes there is appropriate atrial sensed ventricular pacing proceeding from the RV apex while in the later complexes there is loss of atrial sensing with right ventricular pacing originating from the right ventricular outflow tract (RVOT) with subtle oscillations in the axis of paced QRS. On application of magnet, the following rhythm was noticed (**Figure 2**).

distance suggests that the atrial lead is responsible for this paced rhythm originating from the RVOT. As the initial complexes in **Figure 1** suggest normal atrial sensing, the atrial lead is intermittently prolapsing into RVOT causing a change in paced QRS axis and the free lead movement is responsible for the subtle shifts in QRS width and axis seen within the RVOT paced complexes.

The ECG tracing in **Figure 1** is thus explained by the run-away atrial lead which, dislodged from the right atrial appendage, is now intermittently prolapsing in the RVOT. Atrial sensed ventricular pacing originated from the original RV apical lead when the atrial lead was in right atrium; however when the atrial lead prolapsed in RVOT it lost atrial sensing and started pacing with an expected inferior axis. On application of magnet, only the paced rhythm from the atrial lead prolapsed in the RVOT was seen because the magnet caused asynchronous pacing from this lead. The pacemaker spike from the RV apical lead was seen after an expected 'AV delay' of 120 ms with no contribution to QRS complex. Since the atrial lead freely moved in the RVOT, there were subtle changes in paced QRS axis and width.

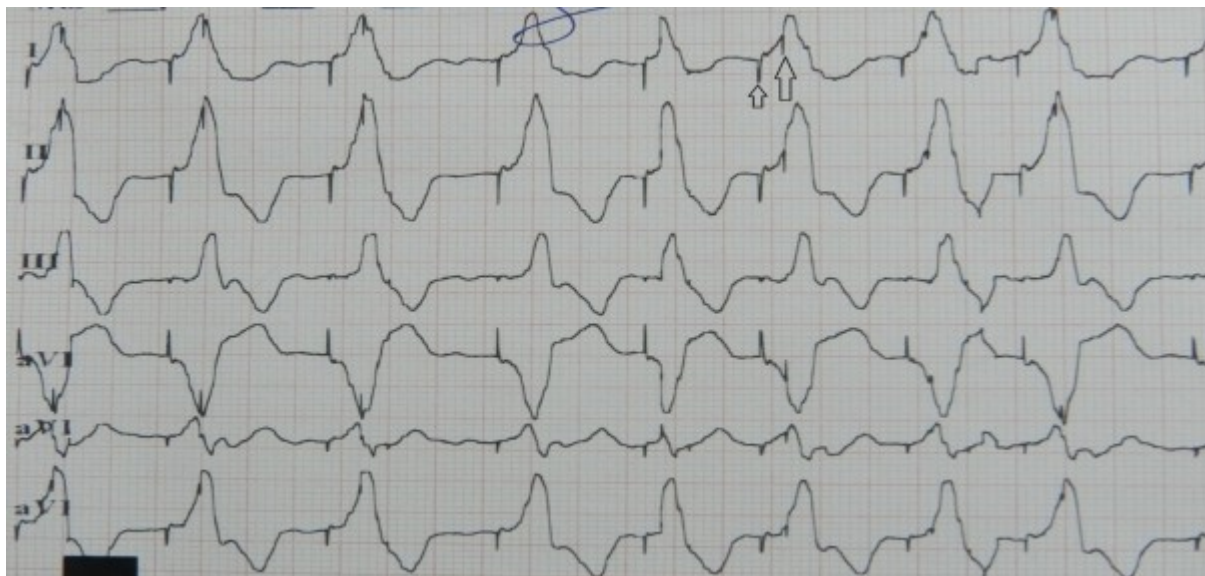
**Figure 2:** ECG with application of magnet after 4 spontaneous paced QRS complexes show two pacemaker spikes (small and large arrow) with interspike interval decreasing to 120 ms.

Before application of magnet, spontaneous pacing is seen with similar QRS morphology as the latter complexes in previous figure with no atrial sensing. However a pacemaker spike is seen buried within the first two QRS complexes with interspike interval of approximately 150 ms. On application of magnet the ventricular rate accelerates to 100bpm, the QRS width varies but morphology remains same, and the interspike interval decreases to 120 ms (small and large arrow). Thus on application of magnet, the ventricular depolarization is occurring from right ventricular outflow tract (RVOT) and presence of both the spikes with shortened interspike

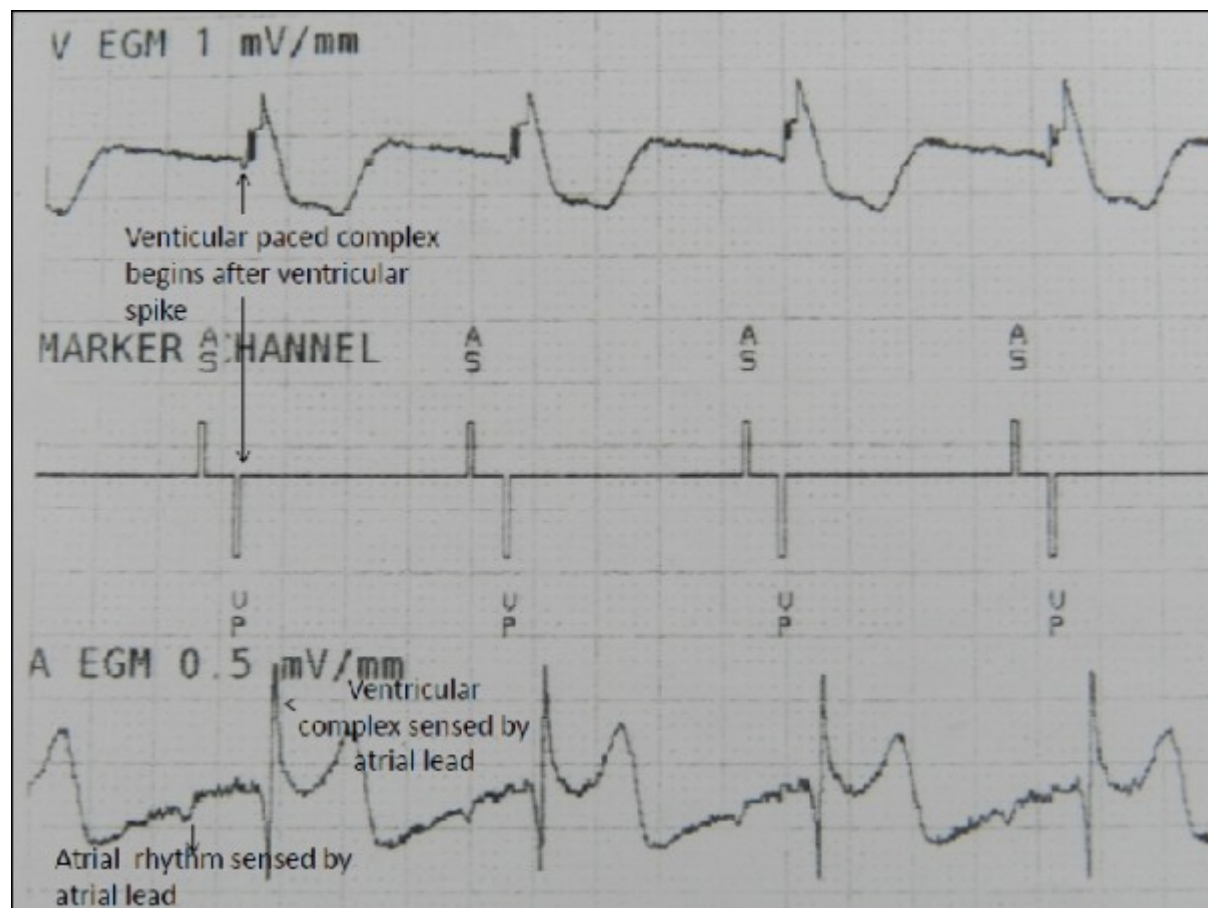
On interrogation of the pacemaker, atrial lead threshold and impedance were found to be high while the ventricular lead parameters were satisfactory. The sensed and paced AV delays of the pacemaker were set at 150 and 120 ms respectively. The following electrogram (EGM) trace was obtained (**Figure 3**). The top most EGM is from the ventricular lead and shows ventricular spike (coincident with Vp seen in marker channel in the middle) followed by paced ventricular complex. The bottom EGM is from the atrial lead and shows sensed activity from atrium (coincident with As seen in the marker channel in the middle). However it also shows a large ventricular EGM at the same time as the paced complex from the ventricular lead. This would indicate that during this interrogation, the atrial lead happened to be in lower atrium thus sensing atrial depolarization but was nevertheless close enough to apical ventricular lead to detect large ventricular EGM.

**Figure 3:** Pacemaker electrogram with top row showing ventricular EGM which shows paced ventricular complexes beginning after a ventricular pacing spike seen on marker channel. The atrial EGM at the bottom shows atrial activity being sensed by the atrial lead but large ventricular complexes are also recorded.

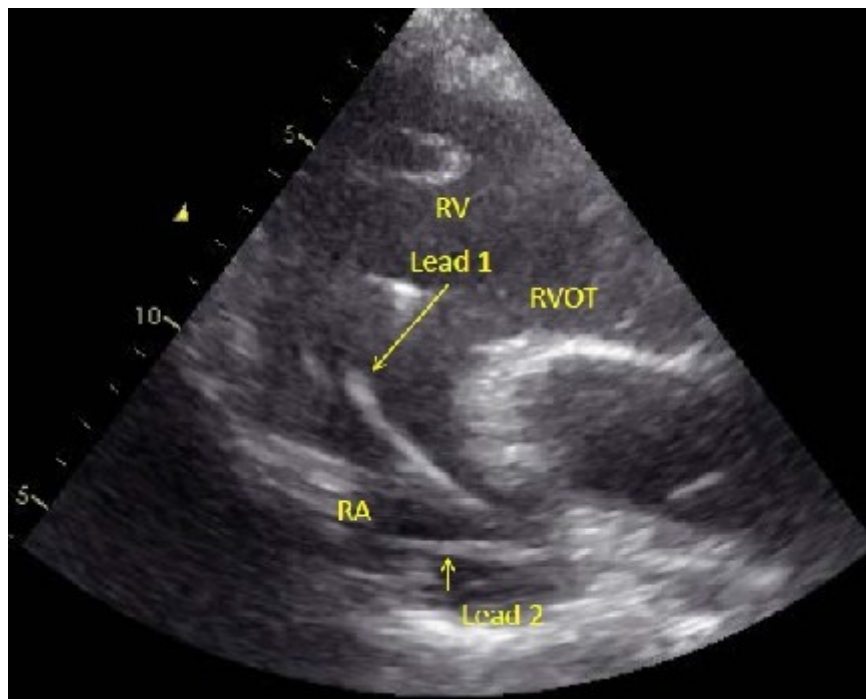
Fluoroscopy confirmed that the atrial lead was indeed dislodged and was intermittently prolapsing in the lower RVOT (**Figures 5**). A trans-thoracic echocardiogram showed normal left ventricular function and confirmed the fluoroscopic findings (**Figure 4**).

**Figure 4:** Parasternal short axis view on 2D echocardiogram showing lead 1 across the tricuspid valve into RV outflow while lead 2 is seen in RA.

A delayed dislodgement of the atrial lead from the right atrial appendage was diagnosed and the patient was explained possible consequences and advised revision of atrial lead. However he refused on grounds of being asymptomatic and subsequently his atrial lead was switched off and pacemaker programmed to VVIR mode. At 3 months of telephonic follow up, patient did not report any symptoms.

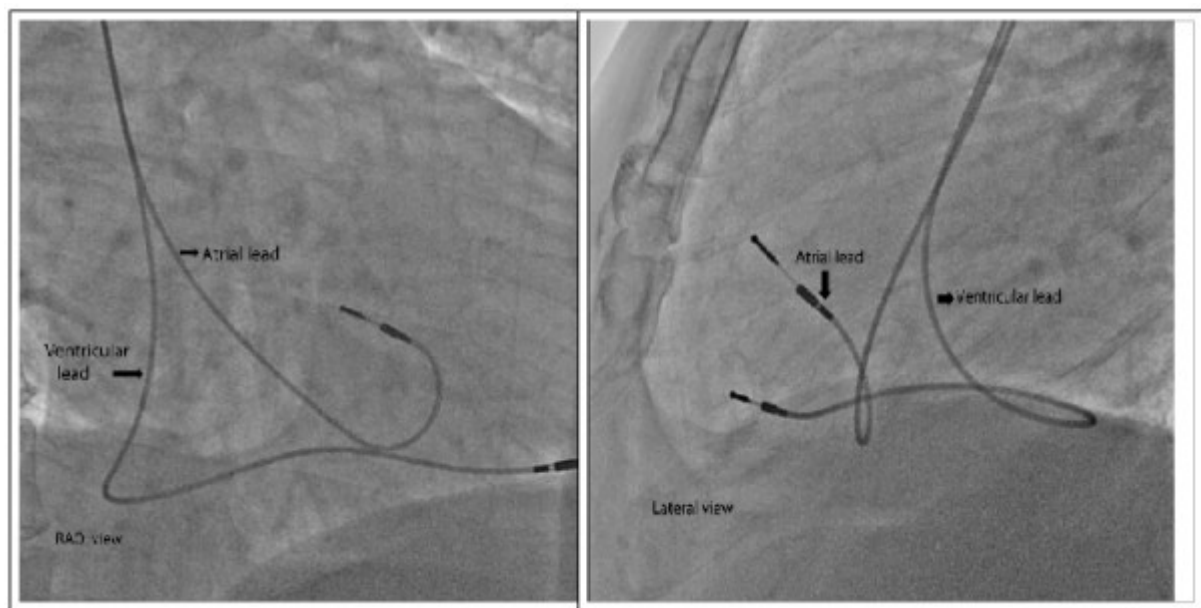
**Figure 5:** Fluoroscopy images in right anterior oblique 400 and lateral views show that the atrial lead is prolapsing into RVOT while the ventricular lead is in RV apex.
